RESERVE FUND STUDY

**174-178 Rutledge Street
Bedford, NS.**

Halifax County Condominium Corporation No. 147

DATE:
April 19th, 2017

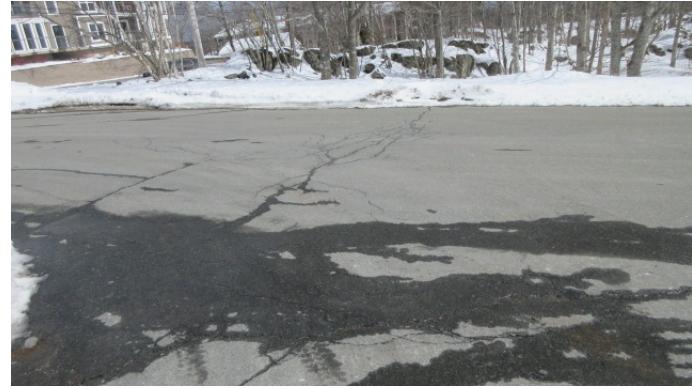
The road is in good condition overall. There are longitudinal and transverse cracks in the asphalt surfaces (photo), and areas of minor settlement.

With continued maintenance, the paving is assessed to have a remaining useful life of 15 years. An allowance is included for replacement of the road and garage driveways in 2032, based on HCCC#165 being responsible for approximately 1/3 of the cost of paving replacement.

(asphalt road - replacement: \$45,000; 2032; 30 year cycle)

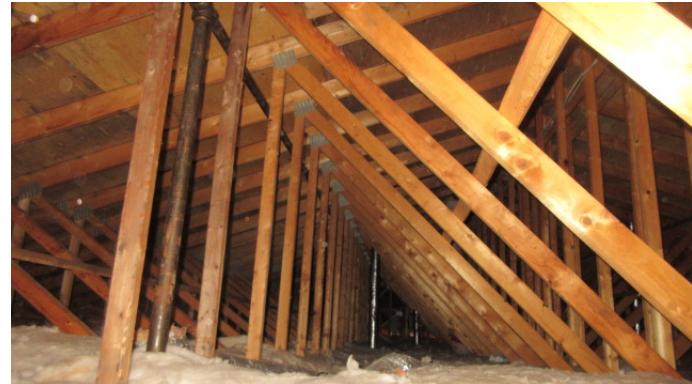
In general the structure is in good condition overall with no evidence of excessive settlement, deflection or vibration observed or reported. No cracks were observed in interior surface finishes. There are minor deformations in all rim boards where there is no lateral support at the exterior wall of stairwells: this appears to be a stable

condition. Some roof sheathing has been replaced locally (photo above), consistent with deterioration from prior leaks in the roofing.

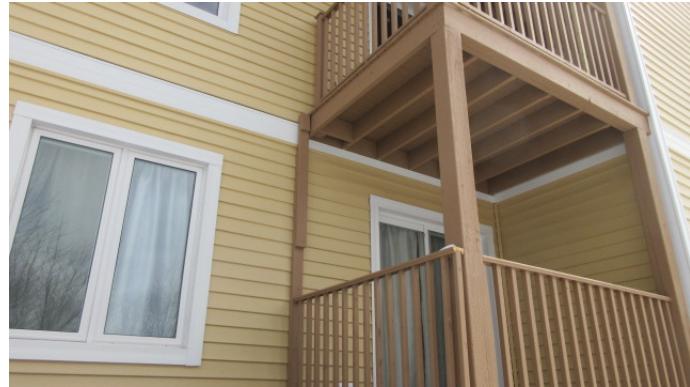
It is reported that all balconies were rebuilt in 2007. Where visible, the construction details conform to new requirements for post dimensions and fastening details.

Where accessed, the railings, framing and deck boards were in good condition and paint-coated recently. With local repairs and continued painting, the balcony framing and railings are assessed to have a remaining useful life of 25 years. An allowance is included for repairs and painting all balconies on an eight-year cycle.

*(balconies – replacement allowance: \$216,000; 2040; 25 year cycle)
(balcony structures – refurbishment allowance: \$36,000; 2024; eight year cycle)*

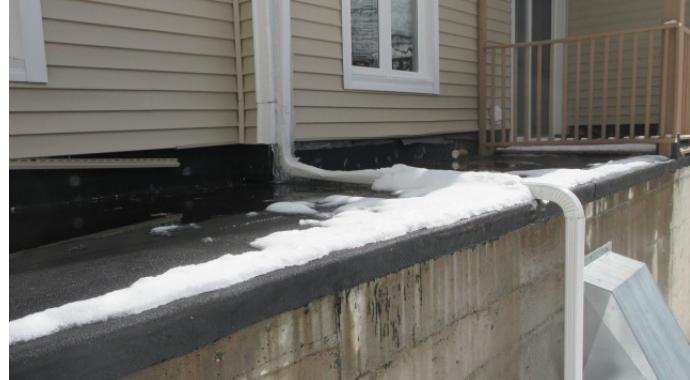
A small area of each parking area is exposed at the respective first floor level, and is protected by sheets of rolled roofing (photo).

The roofing is in good condition overall. Flashing at the adjacent wall above is incomplete; the lack of slope results in ponding on the roofing surface, and the outer edge is unprotected. With repair to flashing, the assembly is assessed to have a remaining life of five years. It is recommended the roofing be replaced with an adhered two-ply modified bitumen system over tapered insulation to provide an expected life of 30 years.

(parking garage roof areas – replace: \$22,500; 2022; 30 year cycle)
